Critical Fitment Warning

Subaru EJ20 - 25 ENGINES

TIMING COMPONENTS

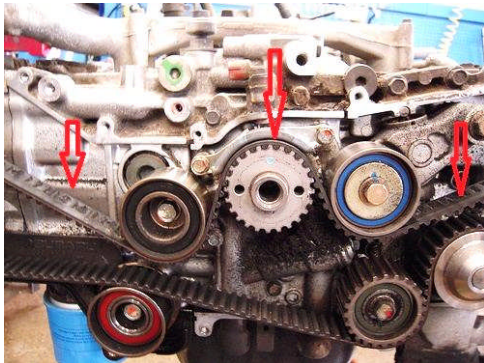
A critical area of installation is checking the OEM manufacturers back clearance specification between the timing belt and the adjustable guide plate around the crankshaft gear. If there is insufficient clearance or the belt comes into contact with the guide plate the extreme heat generated will delaminate the timing belt and cause major bearing failure in a very short period of time.

Fig.1 & Fig.1A Shows an incorrect fitment with the timing belt already delaminating due too excessive heat that will result in a major failure Fig.1A.

This clearance should be between 0.5mm to 1.5mm.

Nason recommend that when fitting a new belt that all timing components and seals are replaced and fitted to OEM manufactures specifications.

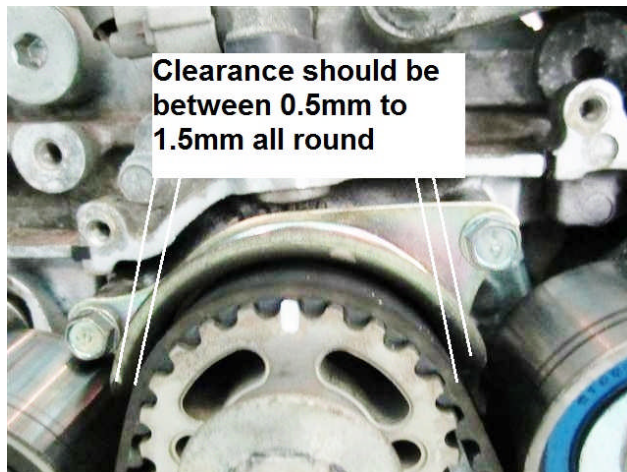
Fig. 2 Shows a correct fitment with clearance set a 1.0mm.
