### TIMING IDLER SPROCKET FAILURE - SUZUKI H27A V6 DOHC 24V

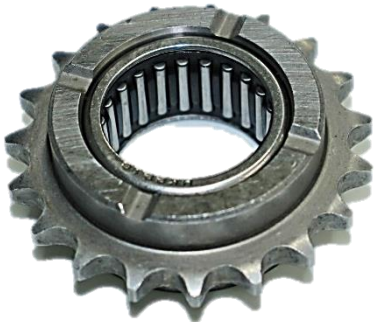
Fig 1  
Idler Sprocket

Due To The High Loads That Are Carried By The Idler Sprocket ( Fig1) It Is Essential That The Idler Shaft ( Fig 2 ) Be Replaced In Conjunction With One Another. This Is Due To Wear & Also The Typical Failure Point Being The Idler Sprocket, Damaging The Idler Shaft Mating Surface.

Fig 1; Idler Sprocket

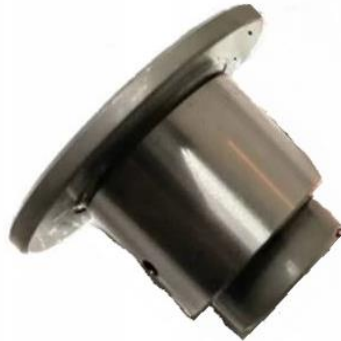
Fig 2  
Idler Shaft

Fig 2; Idler Shaft, **Must Be Fitted** In Conjunction With Idler Sprocket

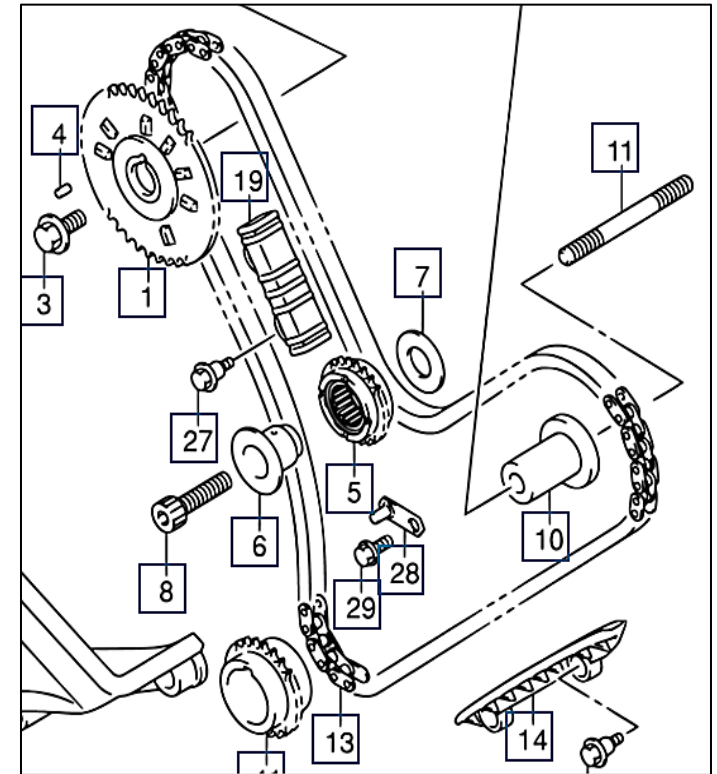
Fig 3

Fig 3; Fig 1 & 2 Displayed As 5 & 6 On Timing Layout Diagram
