**Critical Fitment Warning**

**DRY RUN SCUFFING & CORRECT TENSIONER INSTALLATION.**

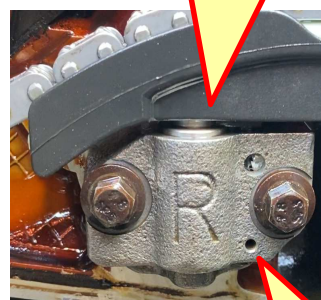
**Note The Ram Has Not Released Correctly After Pin Has Been Removed. Fig 3A Due To Use Of Rattle Gun**

All tensioners are to be installed using the correct OEM torque specification. Rattle guns are **NOT** to be used when tightening tensioner bolts as over tensioning will distort the tensioner. Over tightening will cause the tensioner Ram to jam-up inside the body of the tensioner, not allowing the Ram to release fully & freely.

It's critical that after the tensioner bolts have been torque to the correct OEM specifications, the installer ensures that the tensioner Ram has been released and sitting in the correct position when removing the release pin.

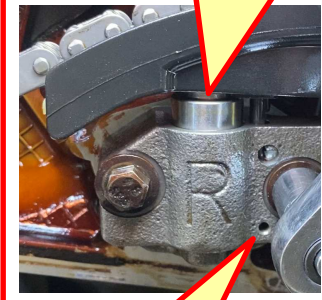
**Note The Ram Has Fully Released After Pin Has Been Removed Fig 3B After Being Torque Correctly**
