It is critical when replacing the valve cover **RCP1021**, that a full inspection of the intake manifold is conducted, failure to do so will cause a failure of the valve cover PCV.

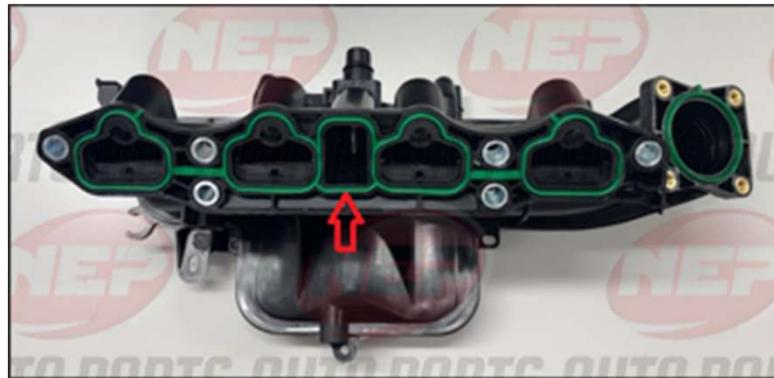
**Step 1:** Via the intake manifold port check that the non-return valve has not been damaged or has been dislodged

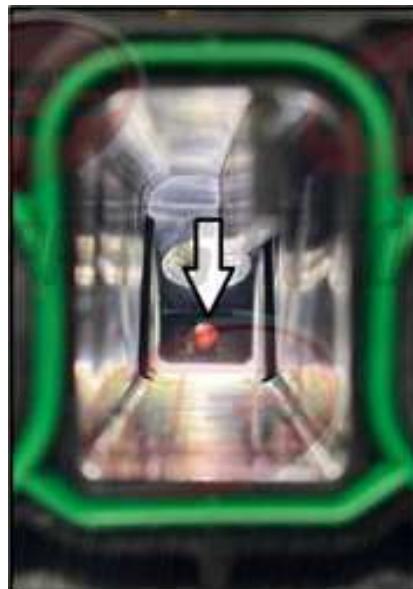
If the non-return valve is **visible**, as per image below, ensure that all ports are cleaned of oil and carbon build up prior to reuse. *Due to the vulnerability of failure of this small component, consideration should be given to replacing the manifold regardless of the inlet manifold condition. Nason part number IMP1002 (Barina) , IMP1003 (Cruze) & IMP1008 (Cruze/Trax)*

If the non-return valve is **not visible**, replace the inlet manifold
