It is critical when replacing the valve cover **RCP1021**, that a full inspection of the intake manifold is conducted, failure to do so will cause a failure of the valve cover PCV.

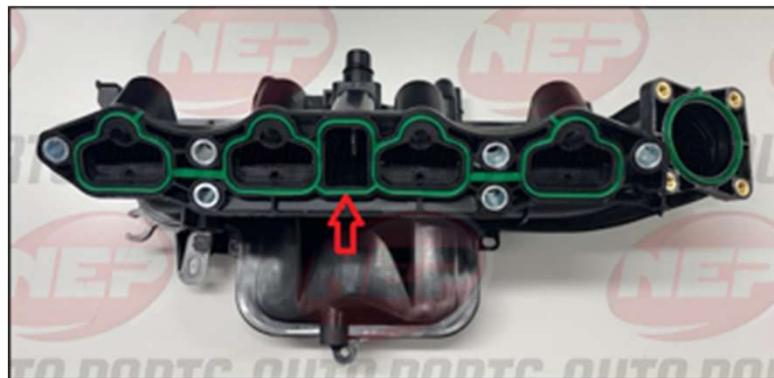
**Step 1:** Via the intake manifold port check that the non-return valve has not been damaged or has been dislodged
