PRODUCT BULLETIN NPB - 19

WATER PUMP INSTALLATION AVOIDING A COMMON FAILURE CAUSED BY EXCESSIVE SEALANT

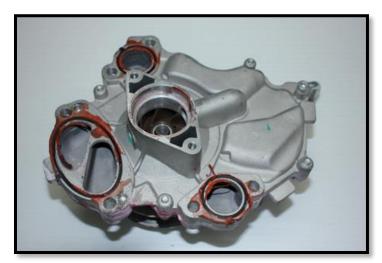
Fig 1: Incorrect & excessive use of sealant

One of the most common issues with water pump failures is, when excessive sealant is applied. The excessive sealant forms a bead on the inner housing of the water pump. This bead eventually breaks away with the force of the water flow. The now solid bead of sealant, under pressure gets forced into the rotating seal area causing the seal to fail.

- ** Water Pumps with Rubber O'Rings should NOT have any sealant applied
- ** Water Pumps with a metal gasket impregnated with a rubber seal should **NOT** have any sealant applied
- ** Water Pumps with a Pre Machined groove generally require the outside of the groove to be filled with sealant. The sealant **MUST NOT** be excessive that it enters the cavity when installed
- ** Water Pumps with either a paper or plain metal gasket can have a <u>VERY LIGHT</u> coating of sealant. This <u>MUST NOT</u> be excessive that it enters the cavity when installed
