T E C H N I C A L R E P O R T

TROUBLE SHOOTING

Water Pump

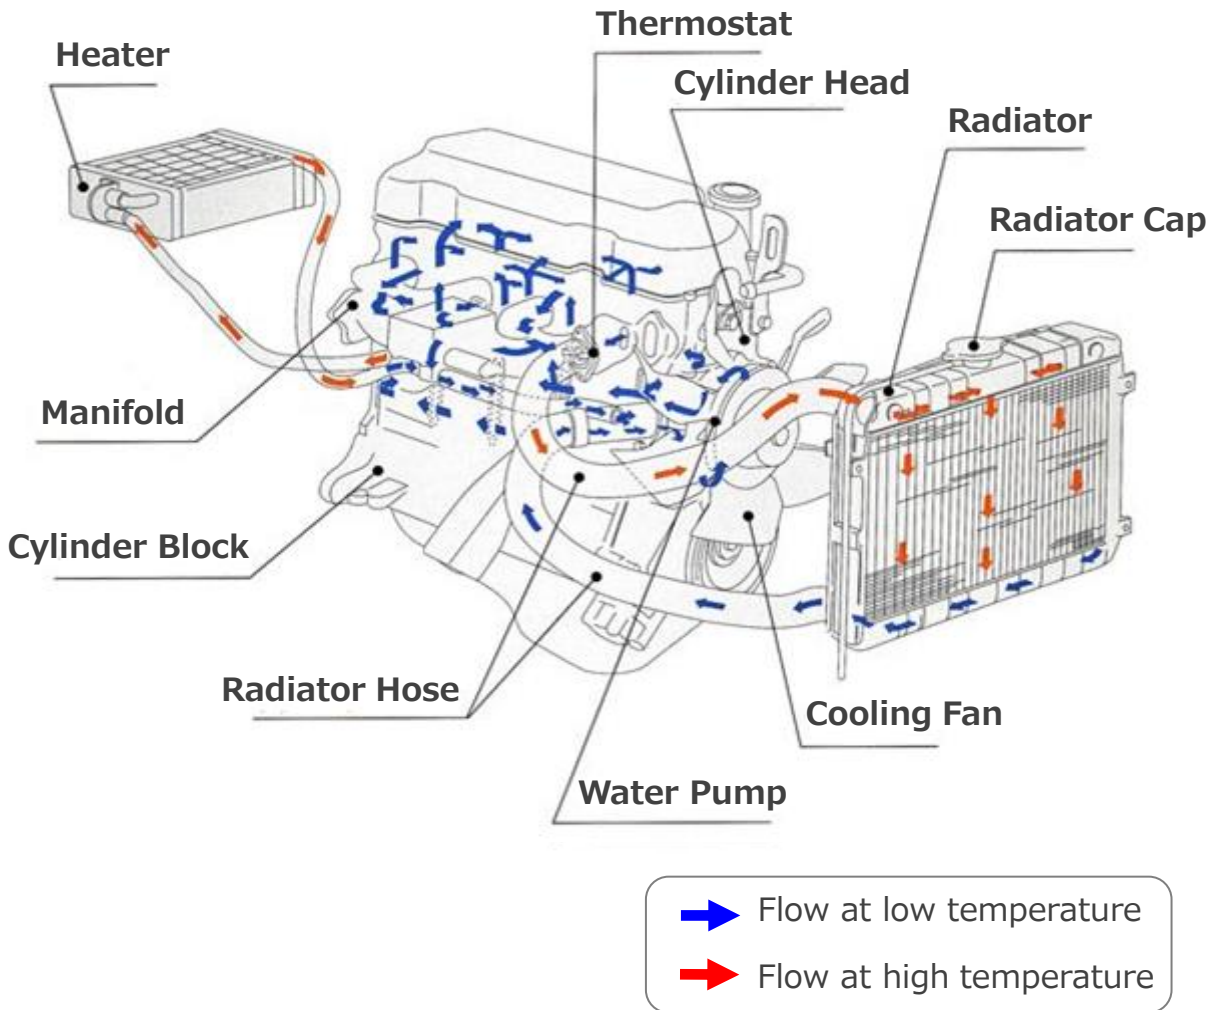
Coolant Flow

Water Pump is integral parts of cooling system and has important roll to circulate the coolant through engine block water jacket and radiator.

Engine heated high temperature coolant is cooled off through radiator and circulated into engine block water jacket.

Water Pump is positioned between engine and radiator, and water pump is driven by belt pulley system, timing belt or fan belt to circulate coolant forcibly.

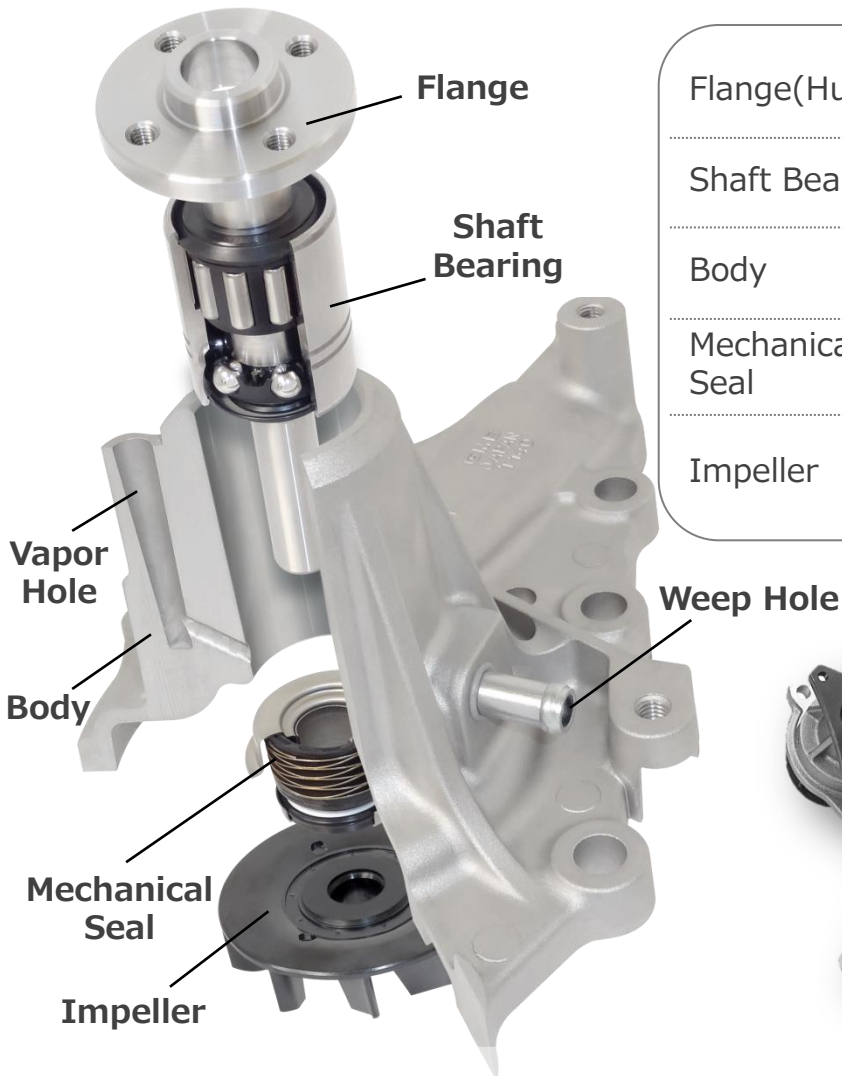
The exploded view of an water pump

Flange(Hub)	Pulley and/or fan clutch are mounted onto the flange.
Shaft Bearing	There are Ball/Ball and Ball /Roller types.
Body	Aluminum with Die-Cast, Gravity-Cast and Cast-Iron
Mechanical Seal	Maintain rotor being closed tightly
Impeller	There are either ,pressed steel, cast-iron or resin type.

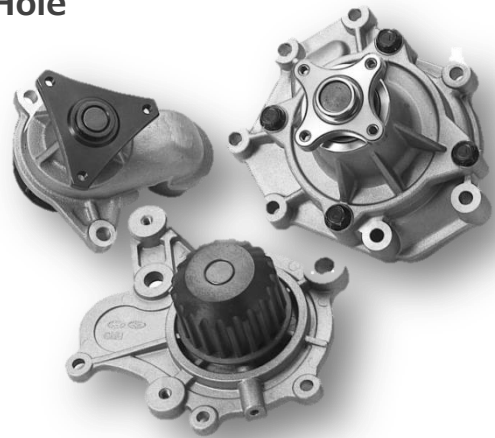
Crank Shaft rotary power drives impeller rotation through water pump pulley and bearing shaft.

The impeller rotation drives coolant into water jacket using centrifugal force and makes coolant circulate.

Coolant filled pump room and water pump bearing is isolated by mechanical seal.

Mechanical seal is dynamic rotation seal type and is always required to rotate in lubricated condition. The approached and lubricated liquid turns into vapor, The weep hole in body has a mechanism to discharge the vapor out of the hole.

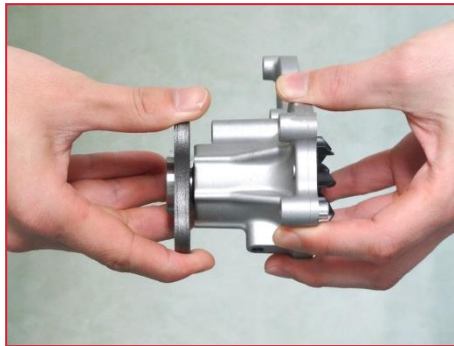
■ Do not dry turn water pump

Do not turn the flange or pulley while mechanical seal contact surface is in dry condition. Turning in dry condition may cause damage to carbon and make squealing noise.

In dry condition, it may make squealing noise but it will stop when coolant lubricates contact surface of mechanical seal after water pump is installed to engine.

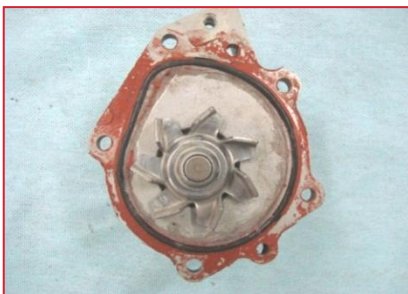
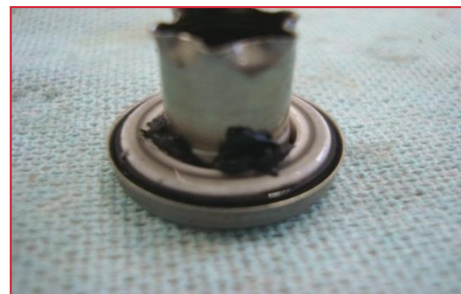
■ Do not apply liquid sealant to O ring

By applying liquid sealant for O ring type seal, excess amount of liquid sealant mixes with coolant inside water channel and intrude into mechanical seal contact surface which will cause leakage.

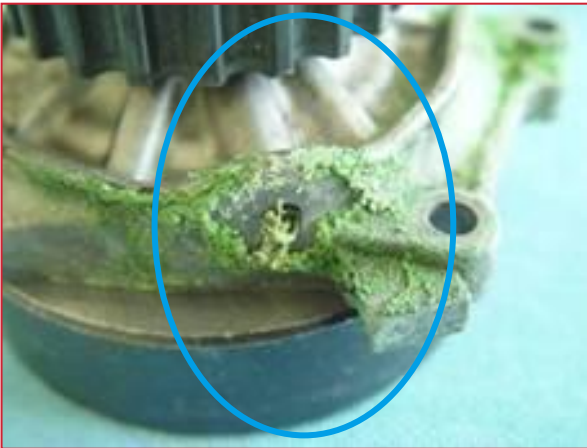
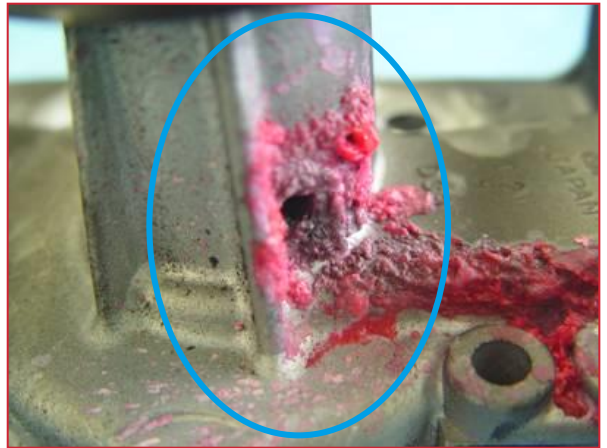
1. Leakage out of weep hole

■ Cause 1. Wear by Coolant

Resulting from sludge or rust from metallic corrosion carried by coolant intruding into mechanical seal surface and abrading sealing surface so sealing performance decreases

□ Prevention

- Coolant needs regular maintenance
- Cooling system should be flushed completely at replacement.

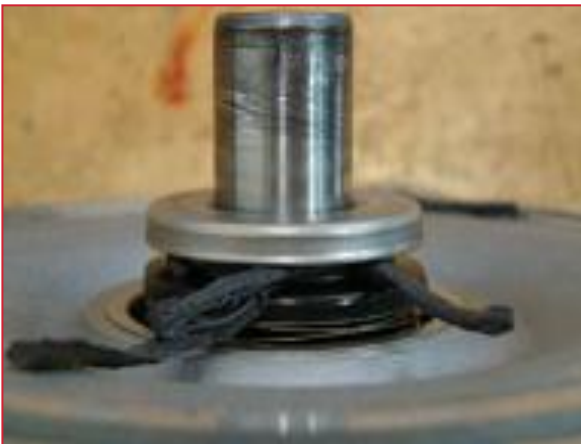
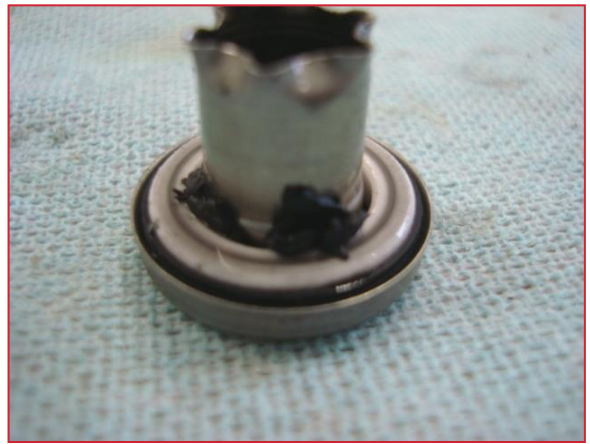
Leakage out of weep hole

■ Cause 2. Usage of excess liquid sealant

Excess amount of liquid sealant mixes with coolant and intrudes between opposing sides of mechanical seal stopping full seal being made and causing leakage

□ Prevention

- Liquid sealant must be applied evenly to water pump gasket surface.
However, do not apply liquid sealant for O ring and metal gasket.

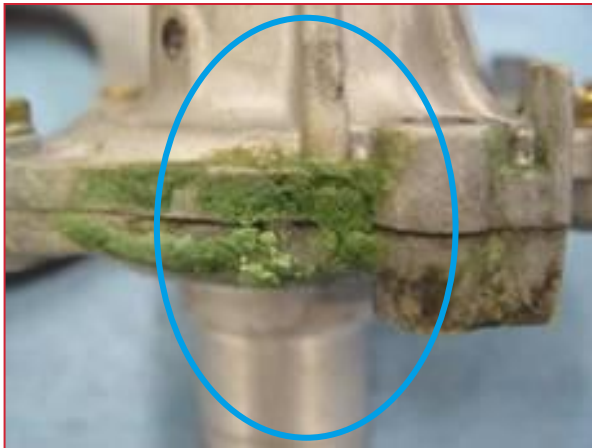
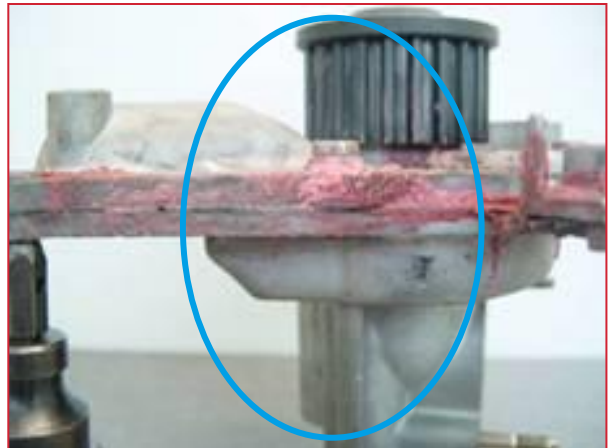
Leakage from Mounting Surface

■ Cause 1. Contamination on mounting surface(Sealant grime etc.)

■ Cause 2. Liquid sealant is not applied

■ Cause 3. Applying sealant on supplied O ring, Metal gasket

■ Cause 4. Improper installation

- Ensure mounting surface is free from remaining gasket /sealant without causing damage on mounting surface

- Apply sealant on both side of supplied gasket

- Do not apply liquid sealant on O ring type seal.

- Tighten mounting bolts using manufacturer's specified torque evenly in a diagonal pattern

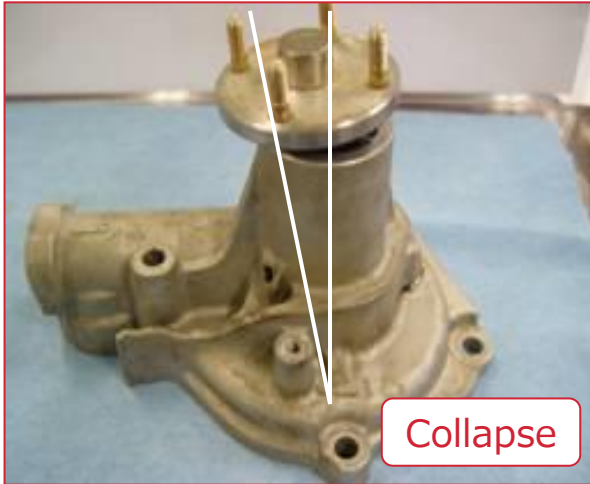
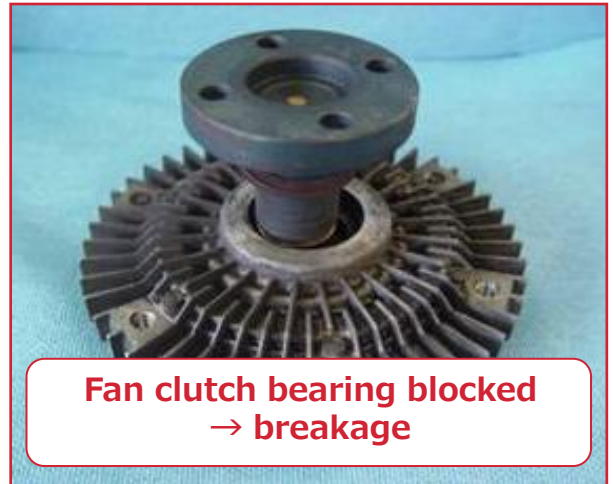
Noise

■ Cause 1. Mechanical seal failure caused coolant intrude into bearing

■ Cause 2. Excess vibration by other installed parts(pulley/fan)

■ Cause 3. Excess belt tension

- Regular coolant maintenance

- Check fully abrasion condition, run-out of pulley/fan and replace them if found abnormal

- Keep belt tension within the values specified by car manufacturer

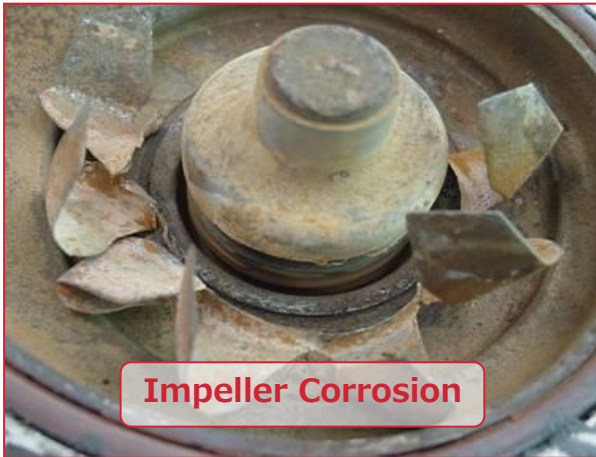
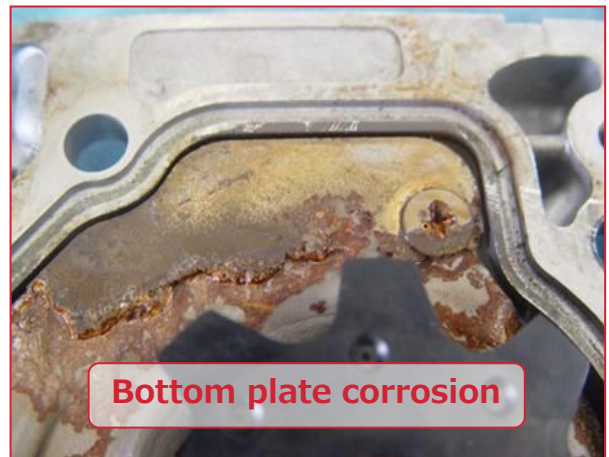
Overheat

- Cause 1. Coolant Frozen
- Cause 2. Corrosion due to coolant deterioration (oxidation etc.)
- Cause 3. Prolonged use of coolant exhausts the rust preventive chemicals and ethylene glycol which are main element of antifreeze turns into formic acid

- Use coolant specified and suitable for cold districts.
Do not recycle used coolant.
Use a good quality coolant with concentration corresponding to respective area climate
- Regular maintenance of coolant.
Before replacing water pump, replace coolant in radiator and engine block water jacket and fully flush
